CARCHEMISH

REPORT ON THE EXCAVATIONS AT (JERABLUS)
ON BEHALF OF THE BRITISH MUSEUM

PART II THE TOWN DEFENCES

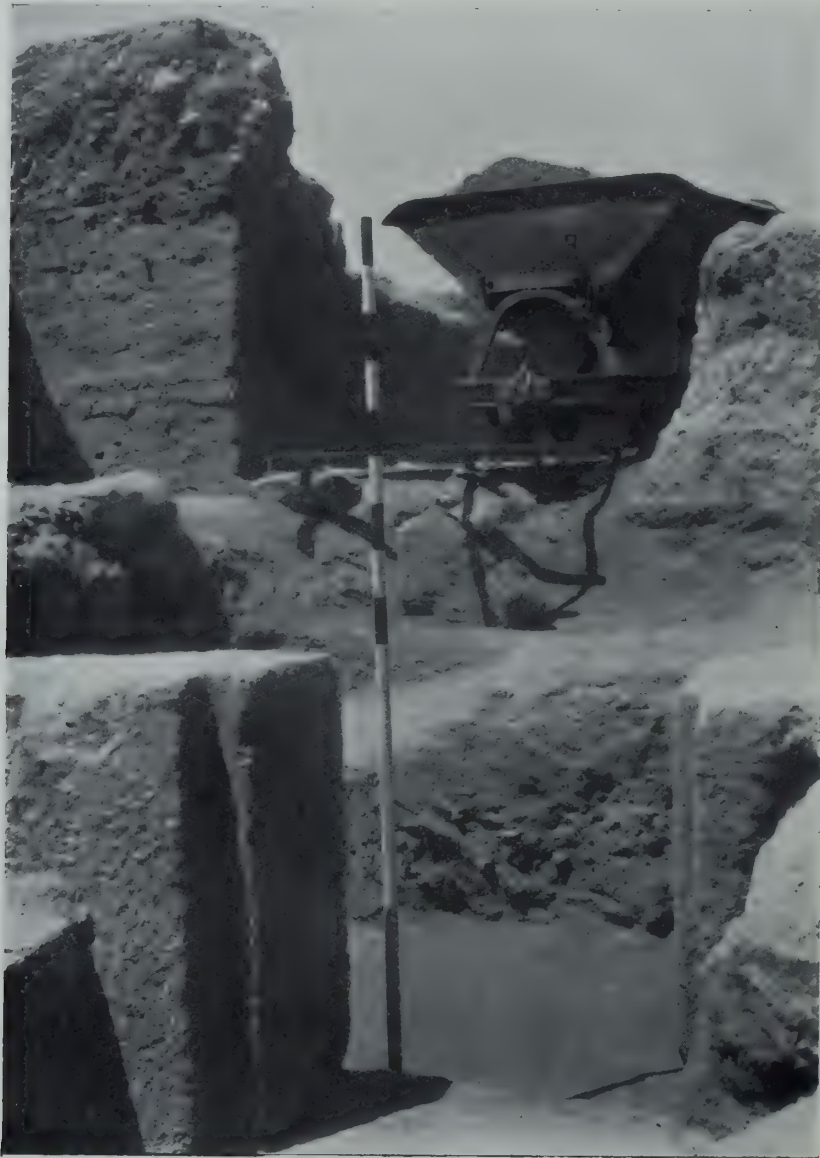
FIG. 10. Ashlar doorway in south-east room of fort.

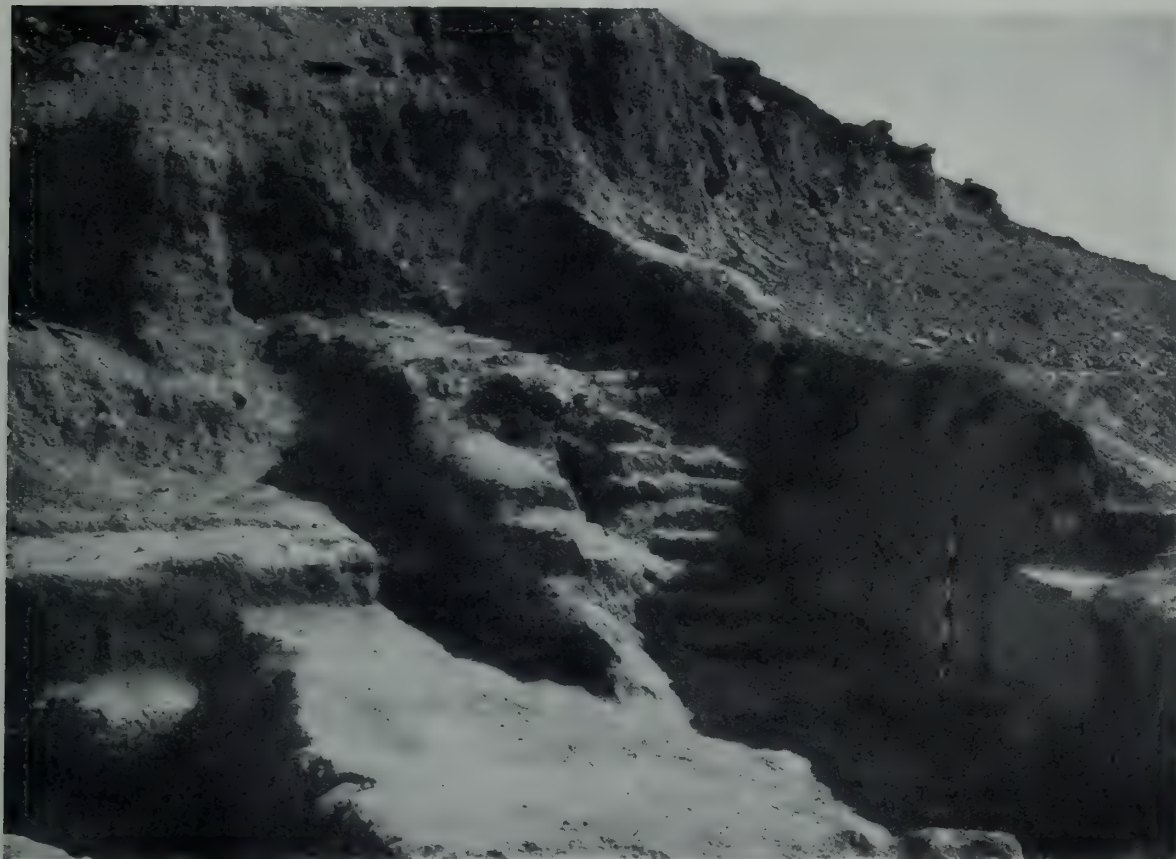
FIG. 15. The staircase in the south recess of the West Gate.

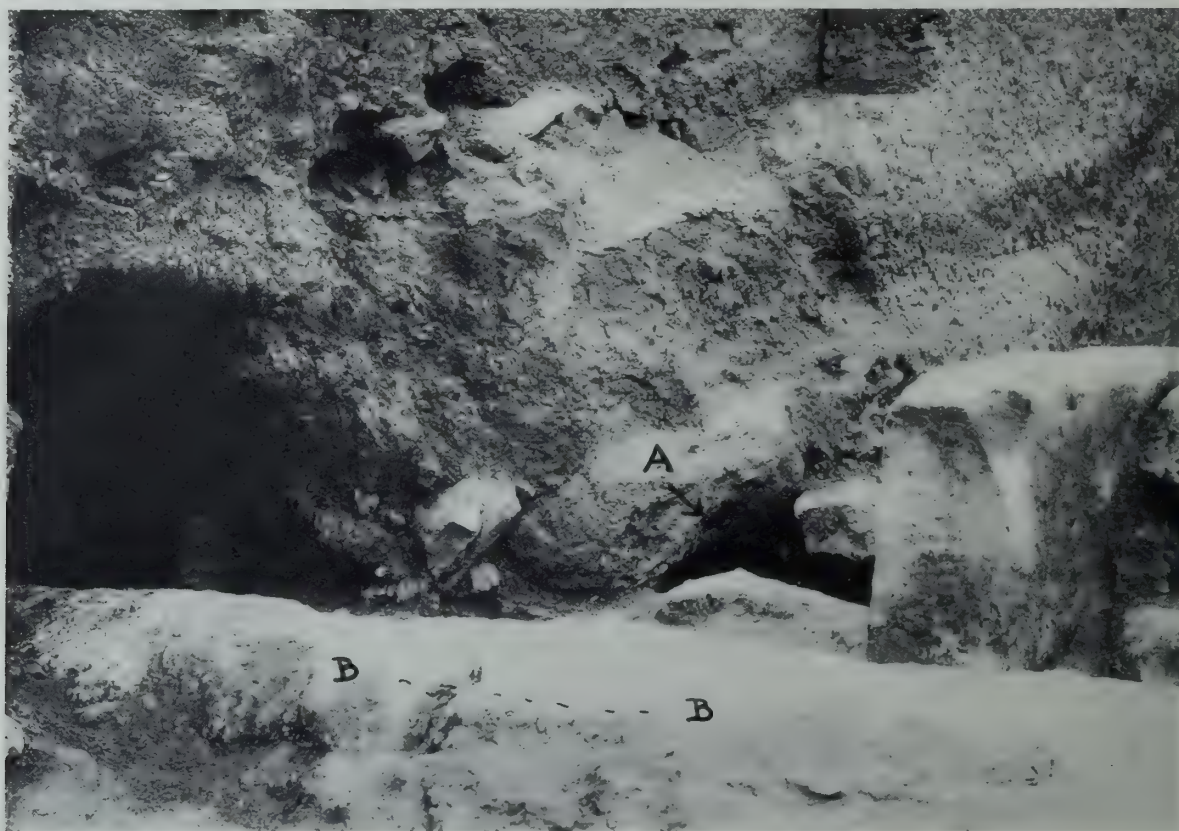
FIG. 16. The blocking-wall in the West Gate. A. The Late Hittite conduit. B. The Roman water-pipe. The wall face was mud-plastered: higher up, the outer skin of bricks has fallen away and actual bricks are exposed.

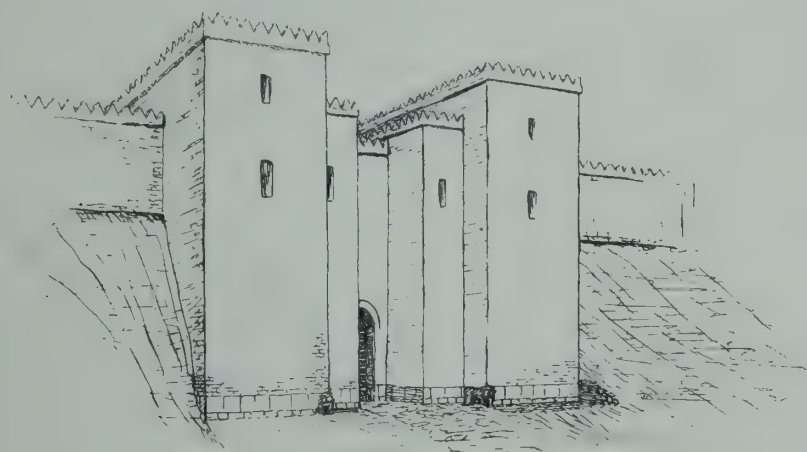
FIG. 22. Restored elevation of the South Gate.

recessed back into the mound. The western tower, on the contrary, owing to the fact that from it the ramparts ran back in a north-west direction, stood out from the mound; the slope of the latter, instead of coming outside the line of the tower's base and so to speak overlapping it, lay well behind it. The peculiar character of the stones in the west face of the tower wall has already been remarked; the greater part of the wall was evidently hidden, but at least half of the corner orthostat and the first ashlar block below it were exposed. On the opposite side of the trench driven into the hillside to follow this wall face the section of the soil showed the line of the original surface of the mound coinciding with what the appearance of the stonework would lead one to expect; the tower projected from the earthwork instead of being recessed into it. This explains the slight difference in the ground-plan of the two sides; on the one extra retaining-walls were required, on the other there was nothing to retain. The restored elevation (fig. 22) shows this feature of the gateway.

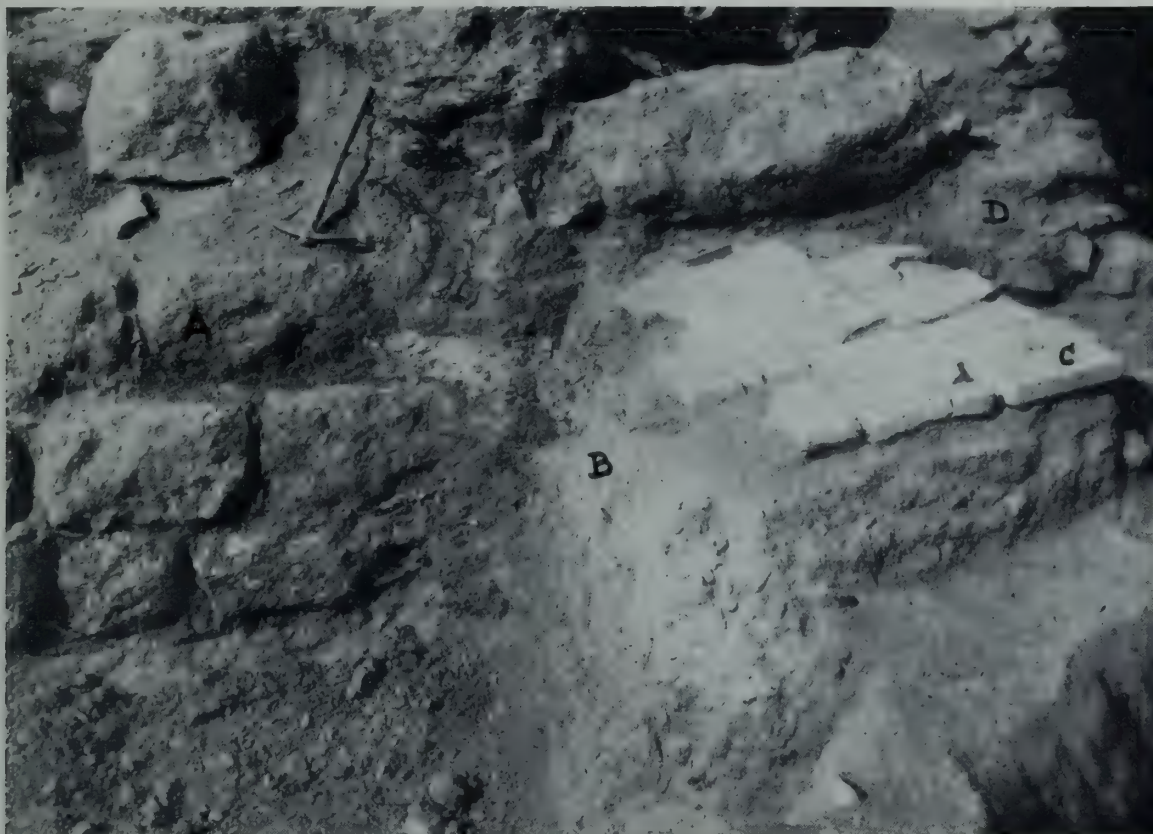
FIG. 23. The south-east corner of the Gate-tower. A. Foundations of the flanking tower. B. Stratum of limestone chips made by dressing the stones at the time of building. C. Pavement of mud brick resting on the builders' rubbish. D. Retaining-wall for the talus of the mound.

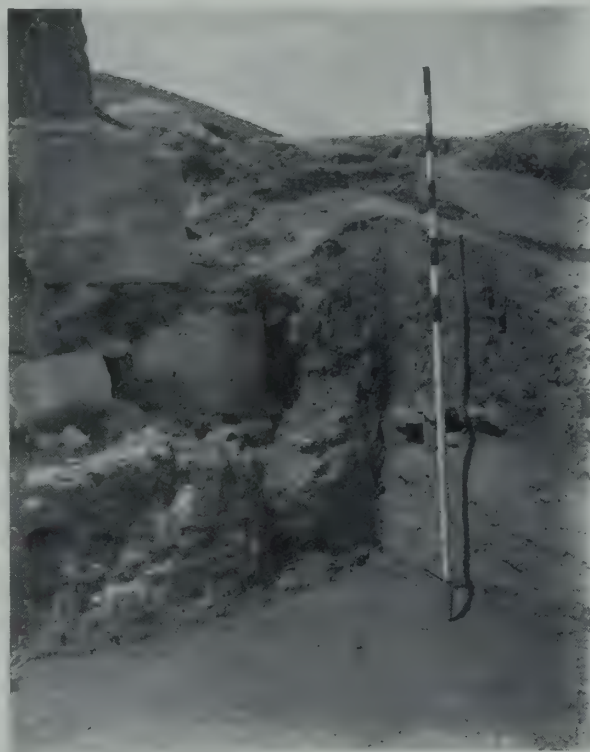
FIG. 24. Recess-wall showing plastered face of Hittite work, and late wall-support of column-drums.

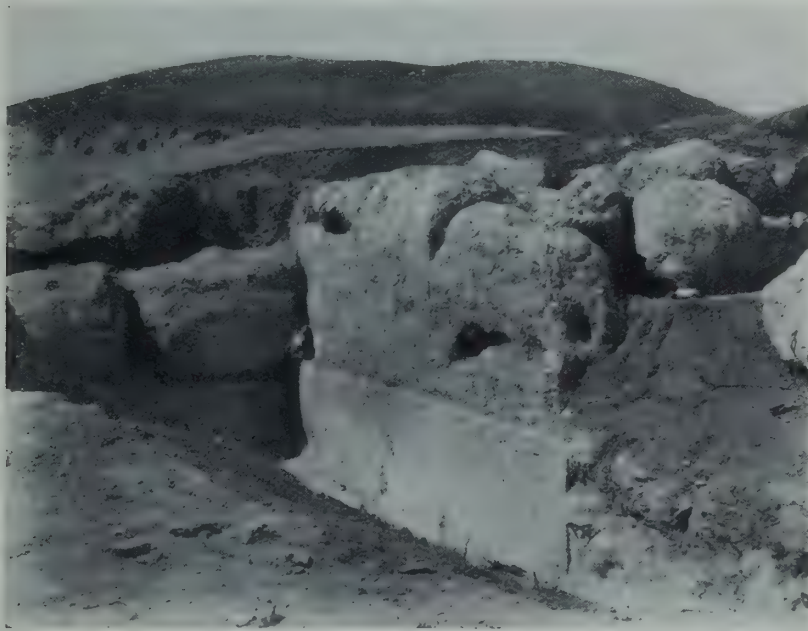
FIG. 29. Ashlar masonry of the south wall of the south-east tower, and the rubble building abutting on it.

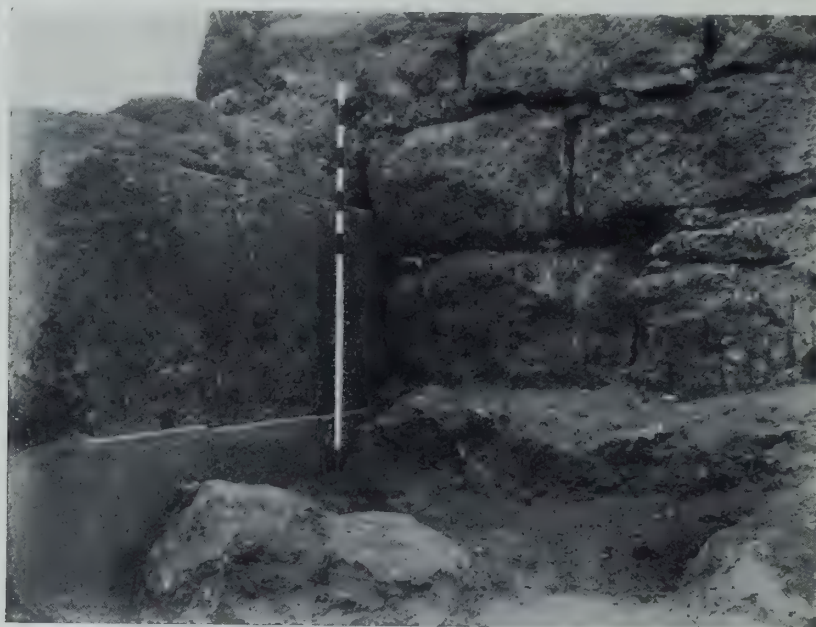
FIG. 30. Ashlar masonry of the north wall of the south-east tower and the rubble masonry masking the angle with the river wall.

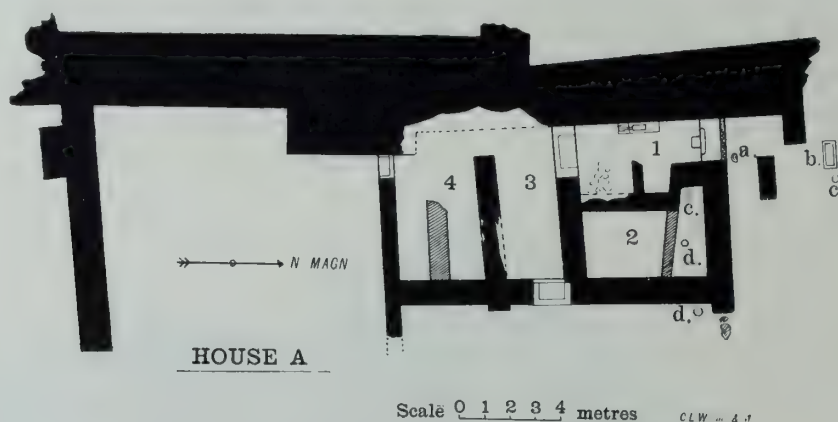
a. Column base. b. Trough. c. Store-jar. d. d. Pot-burials.

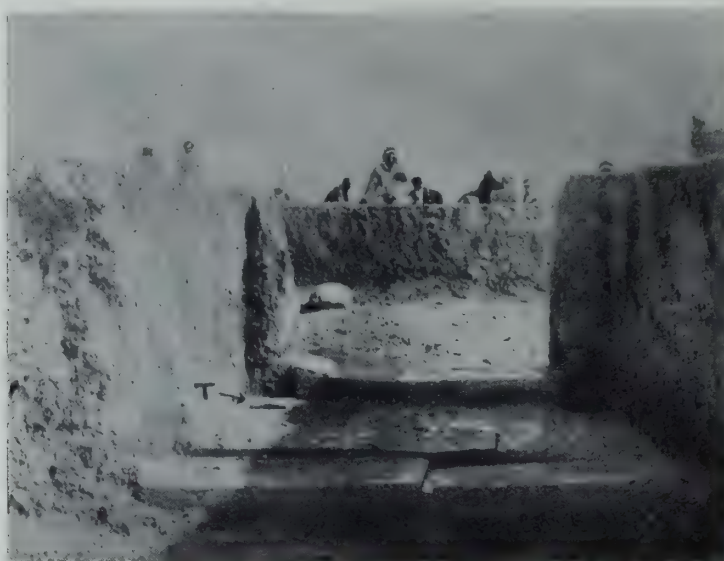
FIG. 39. Doorway of room 5, House D. On the stone threshold lie the cuneiform tablet (T) and a number of arrow-heads.

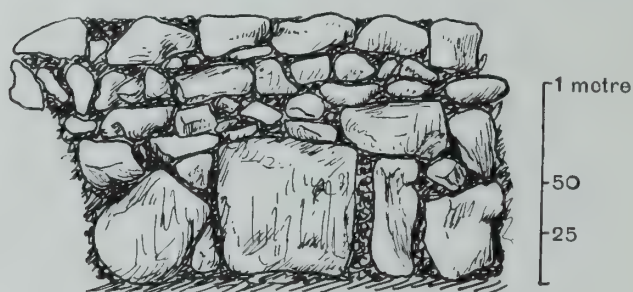
FIG. 55. Rubble masonry, north wall of House C.

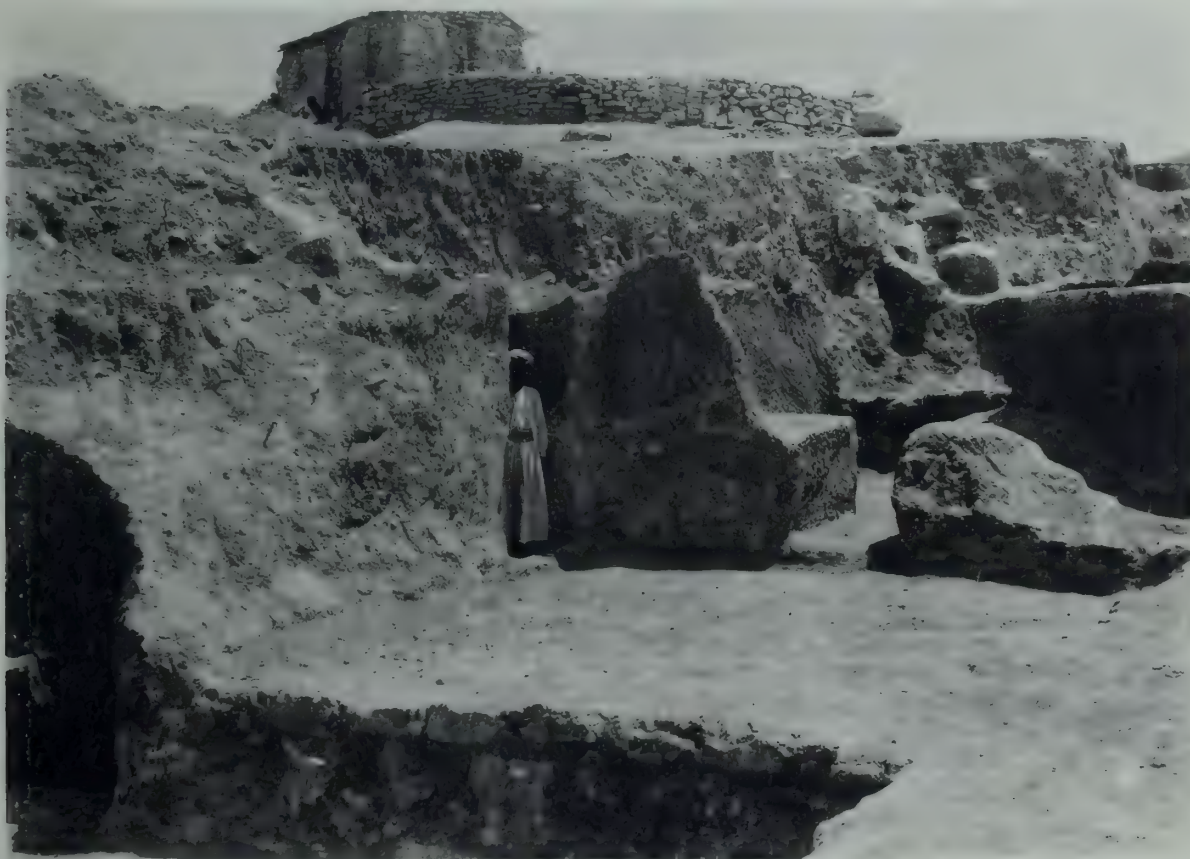
b. THE NORTH-WEST FORT

Whitewashed walls and doorways in chambers of the first period

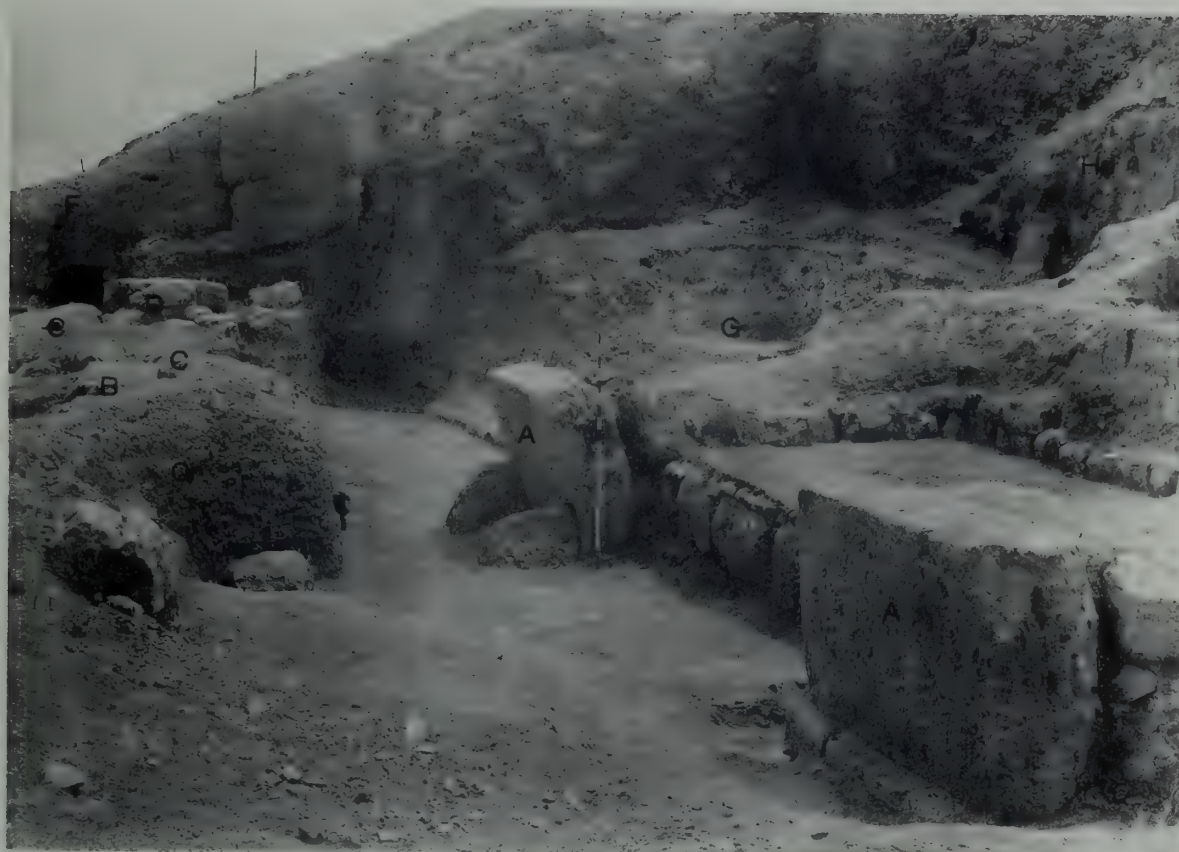
a. THE WEST GATE OF THE INNER TOWN

A—A. 1st and 2nd buttresses on S. side. B. 2nd buttress on N. side. C—C. Roman cement pipe.
D. Late Hittite water-channel. F. Blocking wall. G. Hearth. H. Retaining wall of mound.

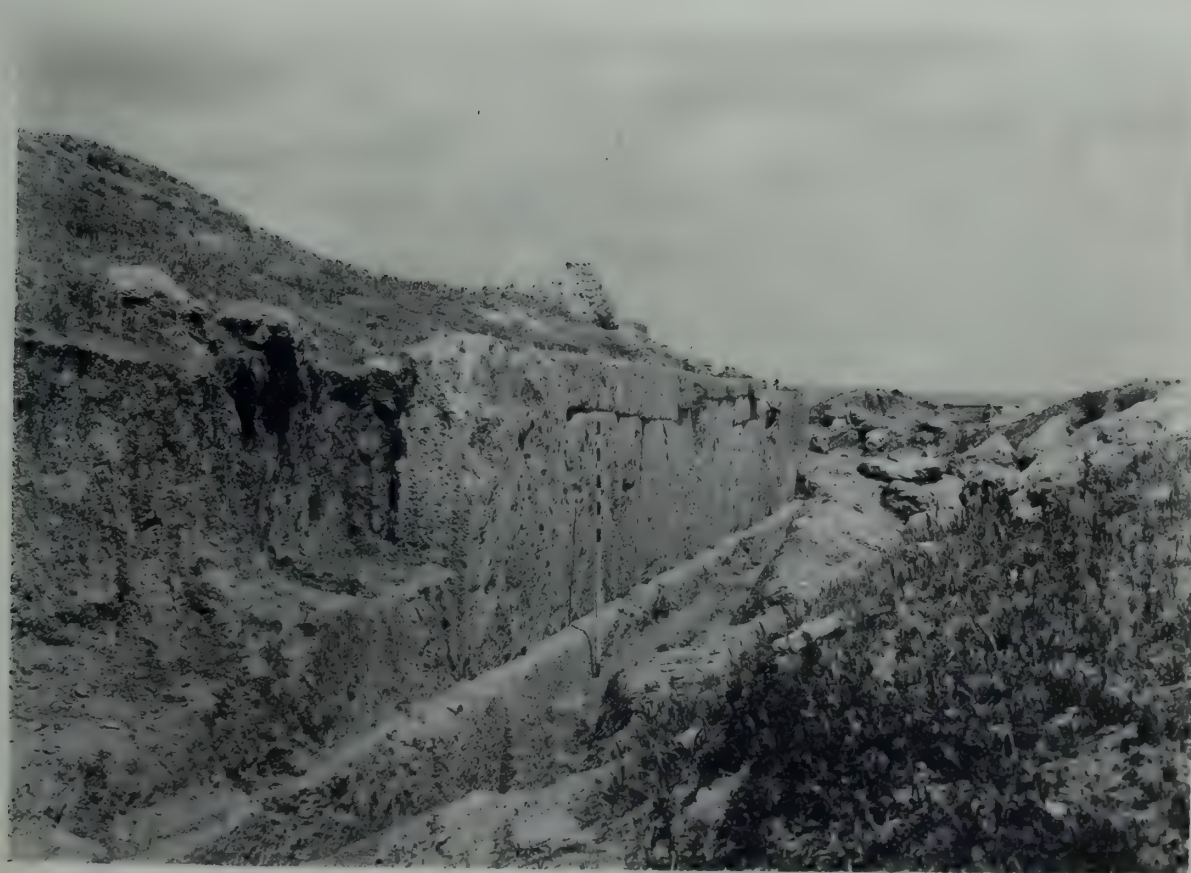
b. THE RIVER WALL OF THE INNER TOWN
View looking north along section B

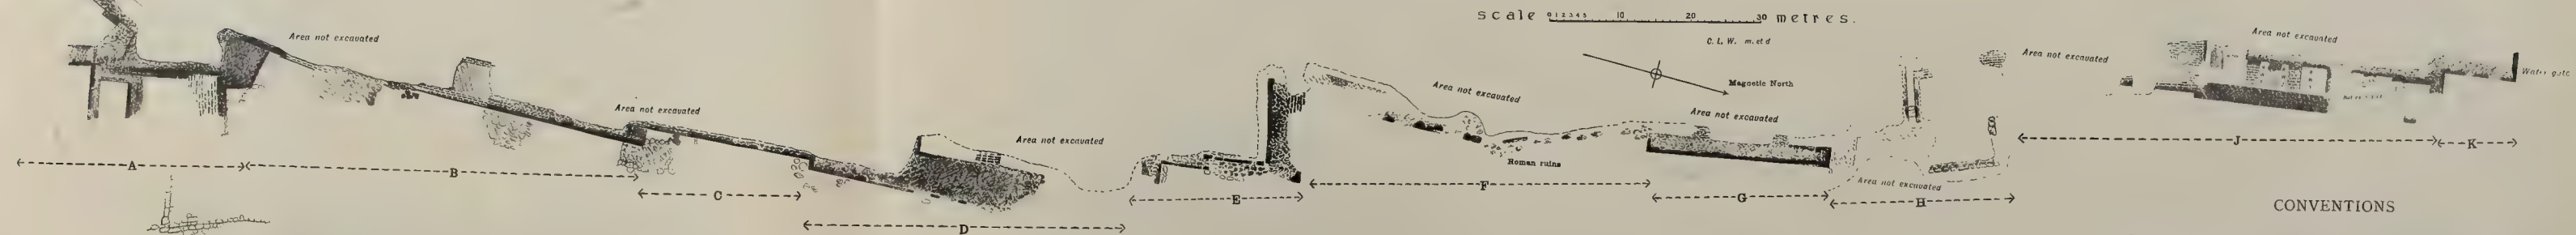
a. PLAN OF THE REMAINS AS FOUND

Brickwork is represented conventionally, not to scale nor in the order of laying.
Bricks standing to the height of 1.00 m. in solid black, below the height of 1.00 m. in diagonal hatching.

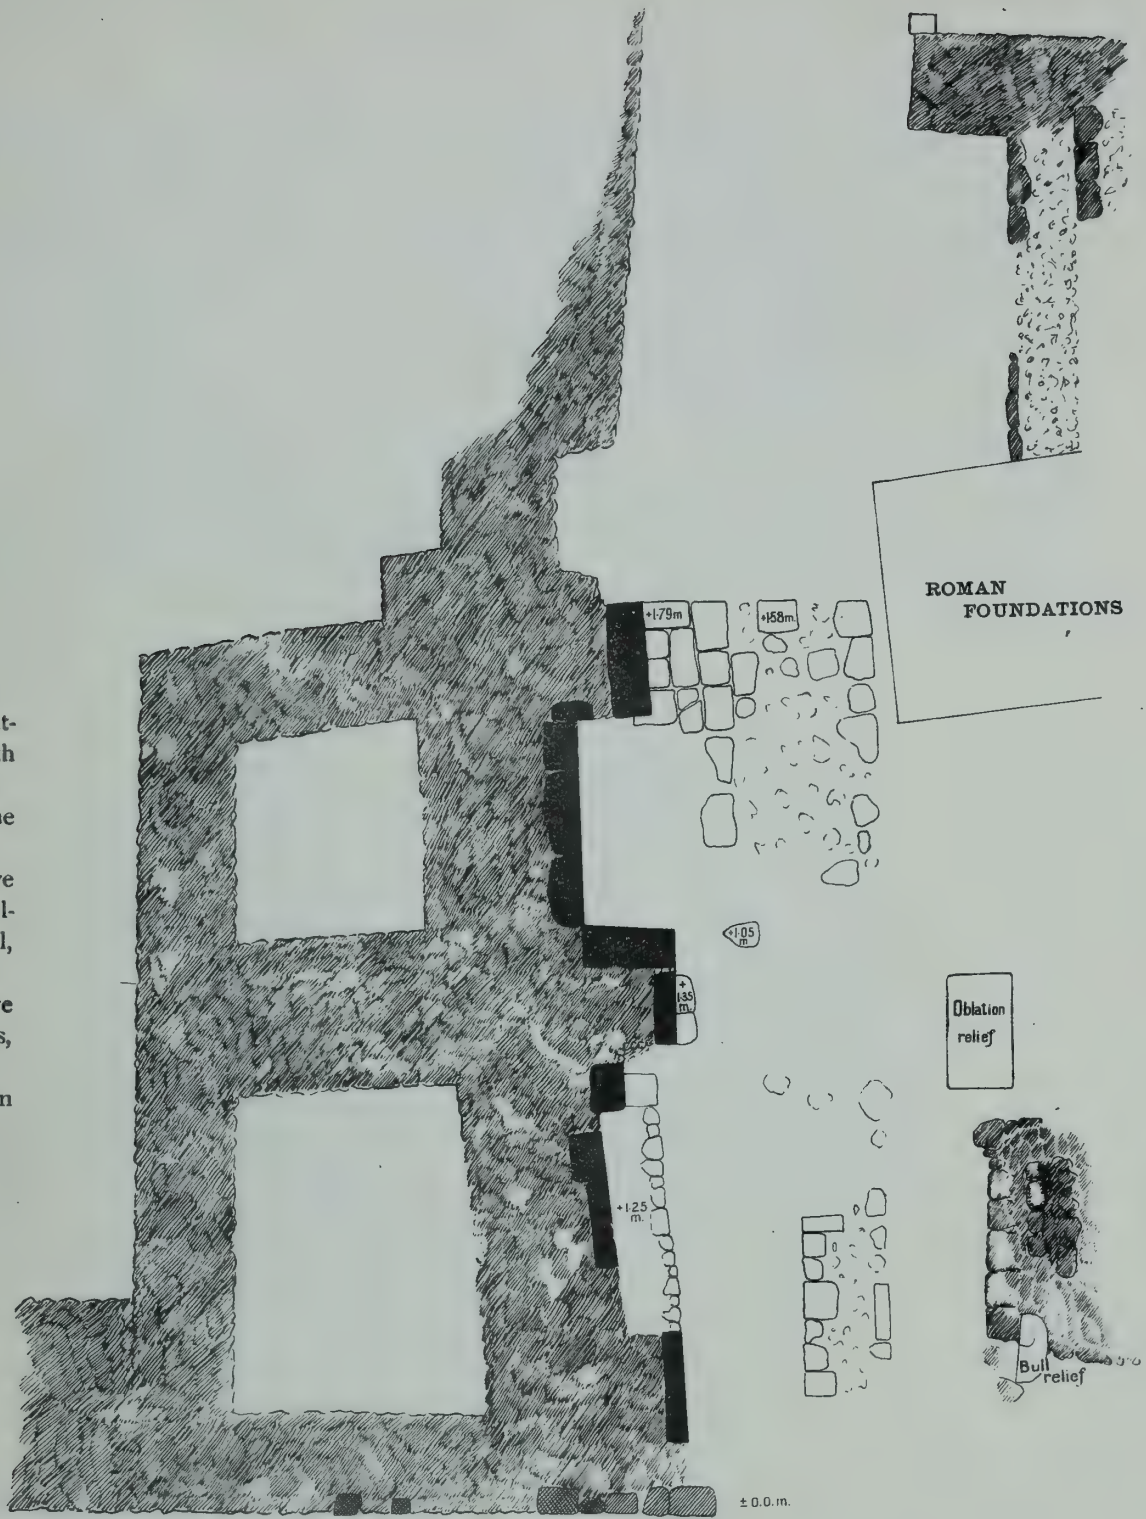
PLAN OF THE WATER-GATE

Stones drawn with completed outlines are to scale; drawn with broken outlines are sketched.
 Pavement stones are in outline only
 Stones at foundation level have plain diagonal hatching; wall-filling at foundation level, broken diagonal hatching
 Rubble masonry standing above ground level, stretcher courses, &c, have cross hatching.
 Ashlar facing-stones in position are in solid black.

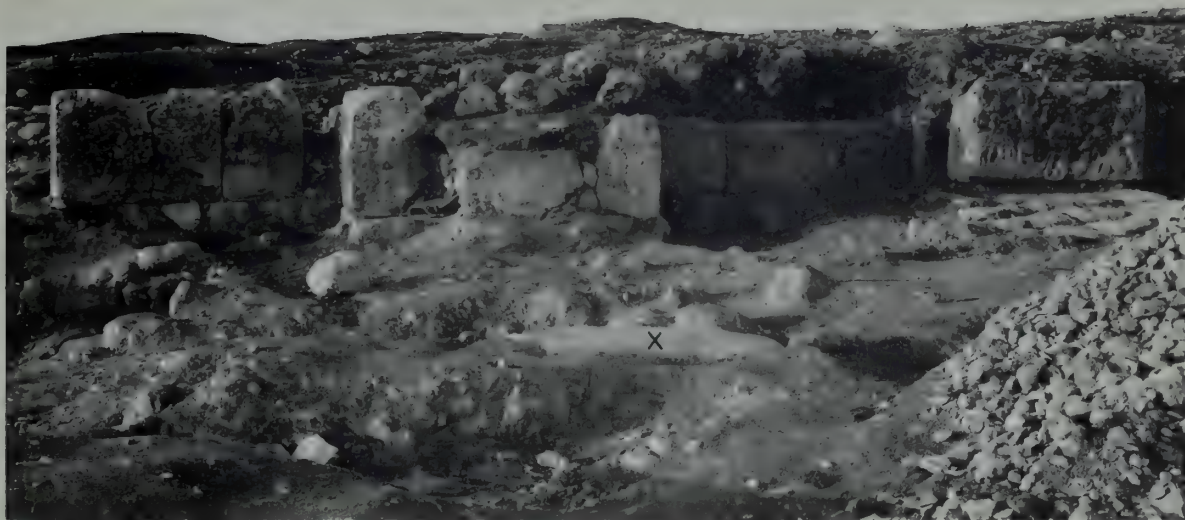
a. THE WATER-GATE, SOUTH SIDE
X. Relief No. 6 as found

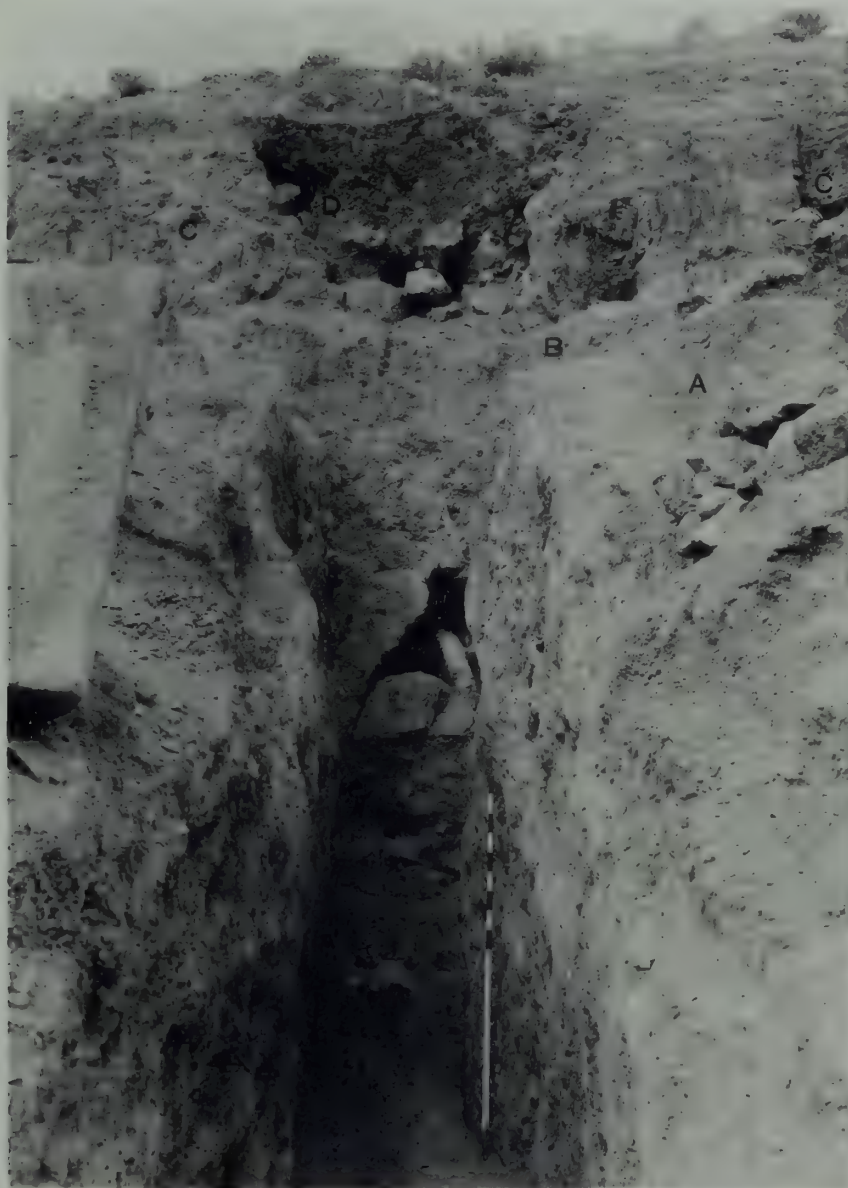
b. THE WATER POSTERN IN THE CITADEL MOUND
A, B, C—C. Successive wall levels. D. Champagne tomb.

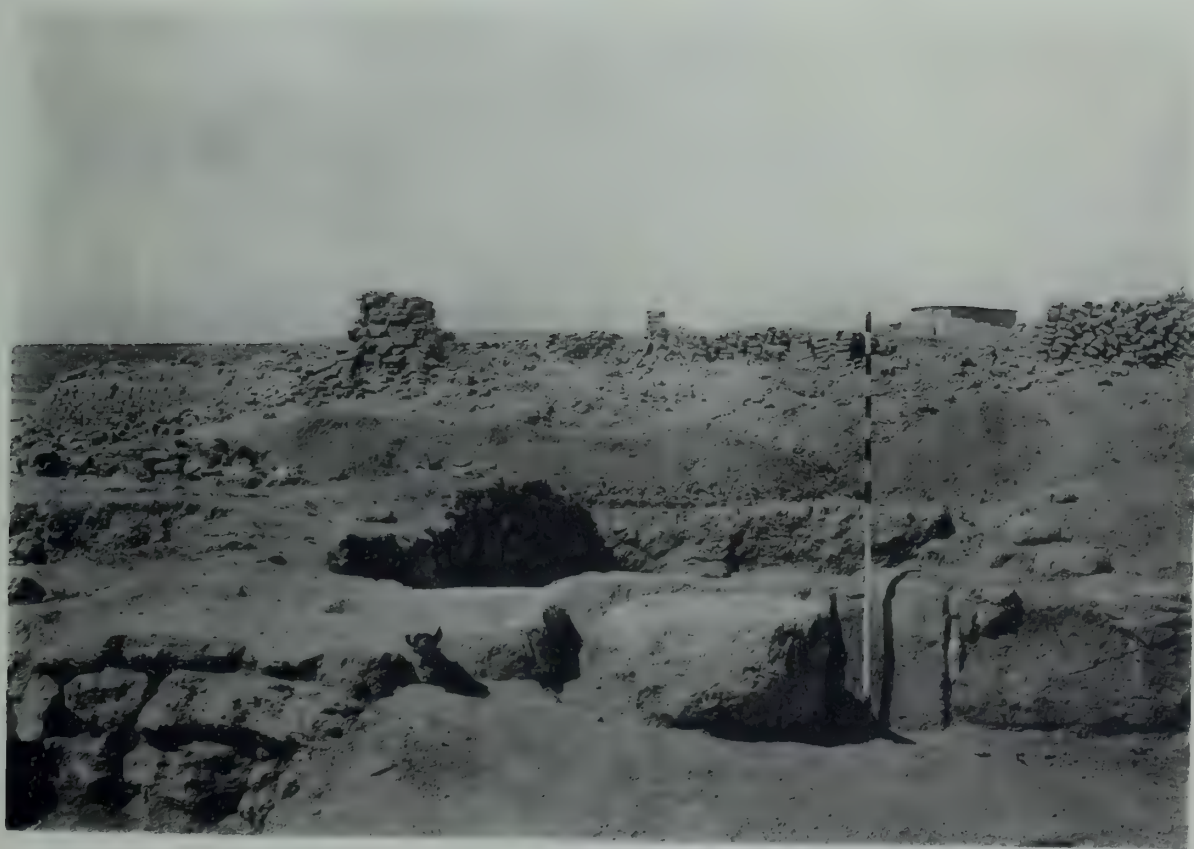
HOUSE C: THE OLIVE PRESS

The outstanding feature of the house was the olive-press which had stood in the middle of it. The limestone base for the press and the basalt trough or basin, their tops just level with the floor, were found *in situ* (Pl. 18 *b*, and fig. 38); against the basin was a rough platform, solidly constructed in stone, a foundation for some part of the press. North of this runs what on the plan is a narrow passage, but the
